Deployment of the Northern Fish Cage and Mooring, University of New Hampshire — Open Ocean Aquaculture Program Summer 2000

September 2000

Technical Report

WHOI-2001-01

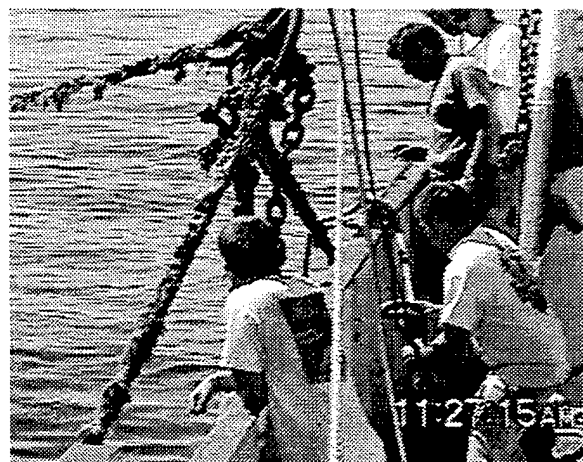
Picture 41. The Northeast grid corner ring with tangled lines and biofouling is recovered and untangled. Wear on the lower grid line is seen in upper left.

The South Cage mooring was inspected by divers earlier in the month and they found that the northeast lower bridle line was fouled around the corner buoy (Picture 41). This was untangled, but was redeployed with a badly chafed rope splice. Afterwards, the old remaining spar crown buoys (northeast and southeast) were brought on board and cut into several pieces for storage. The old buoys were replaced with 37-inch polypropylene floats and shorter chain adjustment links added. The northwest and southwest crown buoys (polypropylene floats) were also pulled and shorter adjustment chain replaced the old crown line chain. Upon replacement of each crown line chain, the *Nobska* would pull and tighten the anchor leg.
